IABSE Bulletins  
Case Studies

CS3

# Investigation of the Chirajara Bridge Collapse

On January 15, 2018, at 11:49, the west pylon (B) of the cable-stayed Chirajara Bridge collapsed during construction of the bridge girder. The crossing is located approximately 20km NW of Villavicencio, Colombia. The collapse led to the complete destruction of Pylon B, together with the erected span of the bridge girder. Authorities reported nine fatalities resulting from the collapse.

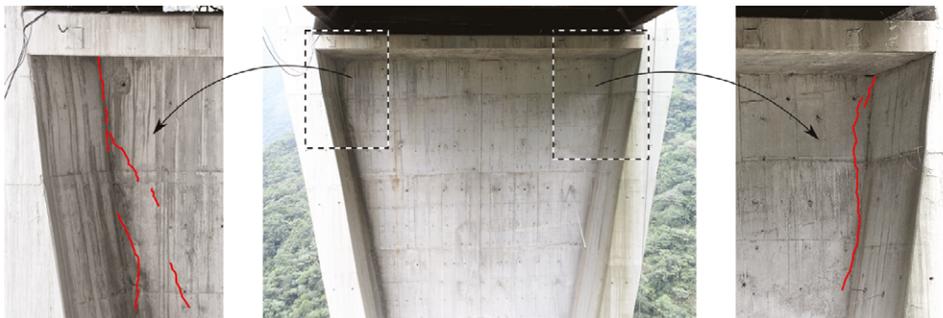
Apart from the depth of the foundation caissons, Pylon B and Pylon C were identical in their structural design and configuration. Furthermore, the superstructure supported by Pylon C was slightly behind Pylon B in construction, leading to an approximately 82ton load deficit for Pylon C in relation to Pylon B (see Section 3.2.1). An inspection of standing Pylon C revealed the existence of two discrete vertical cracks in the diaphragm, starting from the uppermost corners, as can be seen in the photos in *Fig 10.1*. From this, it is seen that Pylon C reacted in the expected manner to the progressively increasing construction loads, i.e., through concentrated cracking of the diaphragm in the uppermost corners and, as a consequence, concentrated strains in the connecting reinforcement between the diaphragm and the pylon legs. This is described in this report as the first stage of collapse of Pylon B. Therefore, it is reasonable to conclude that Pylon C was on the verge of collapse before it was demolished. As its load deficit in relation to Pylon B was the main reason for it not collapsing before its demolition, any additional loading due to, e.g., working activities, vehicles, equipment, extreme temperatures, wind, or seismic actions, could have led to a collapse of the pylon, in a similarly catastrophic manner to what was observed on Pylon B and again without warning.

**Fig. 10.1** Pylon C discrete vertical cracks in the uppermost corners of the diaphragm

This does not imply that Pylon C could not have been hypothetically salvaged. Having identified the bridge deficiencies, appropriate strengthening and retrofit of the pylon, cables, girder, anchorages, and abutments could have yielded a serviceable part of a new bridge. What should be made clear though is that the risk to human life and the poten-
