The Reconstruction of the Cast Iron Railway Station from 1865

Milan VAŠEK

Czech Technical University
Prague, Czech Republic

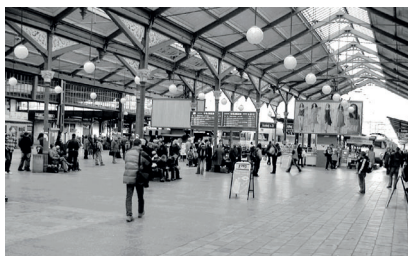
Fig. 1 The hall of the Masaryk's station

The hall has a rectangular plane view 28,45 x 67,7m designed as a three-bay system (11,67 m – 5,01 m – 11,8 m) (Fig.1). The longitudinal spacing of the main structural frameworks is from 3,81 m to 4,73 m. Every second frame is supported by hollow cylindrical cast iron columns. These columns have served as rainpipes for about 146 years without substantial damage due to a corrosion. The timber roof system is formed by three hinged trusses with wrought iron draw bars. The longitudinal stiffness is ensured by doubled rafters with struts and wrought iron draw bars. The trusses are embedded in cast iron shoes. Some iron draw bars were removed during the
