Glass Fibre Reinforcement in Bridge Barrier Walls

Summary

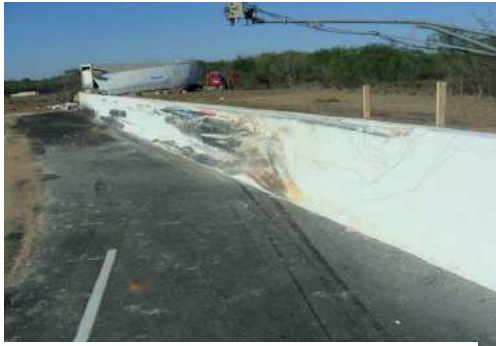
The barrier sustained cosmetic damage only in the form of tire marks and gouges into the concrete as shown in Fig. 2. Minor cracks in the front and back side of the barrier were observed. The barrier was first hit by the tractor. Subsequently it was hit a second time by the rear end of trailer at a similar point. The second impact caused a punching shear crack. There were no signs of vertical flexural cracks at back face of the barrier wall at the point of impact, as they would be expected based on the yield line failure pattern specified in AASHTO-LRFD Specifications. A horizontal crack had formed at the front face of the barrier wall extending from the point of impact downstream to the following control joint at mid-height of the barrier wall.

Figure 2: Wall and tractor trailer after the test
